# FLIGHT TEST EVALUATION OF OH-58A TAILBOOM FAILURE DURING AUTOROTATION LANDINGS

Thomas L. Sanders  
BELL HELICOPTER COMPANY  
Post Office Box 482  
Fort Worth Texas 76101

14 March 1973  
Final Report

REPORT No. 206-194-134

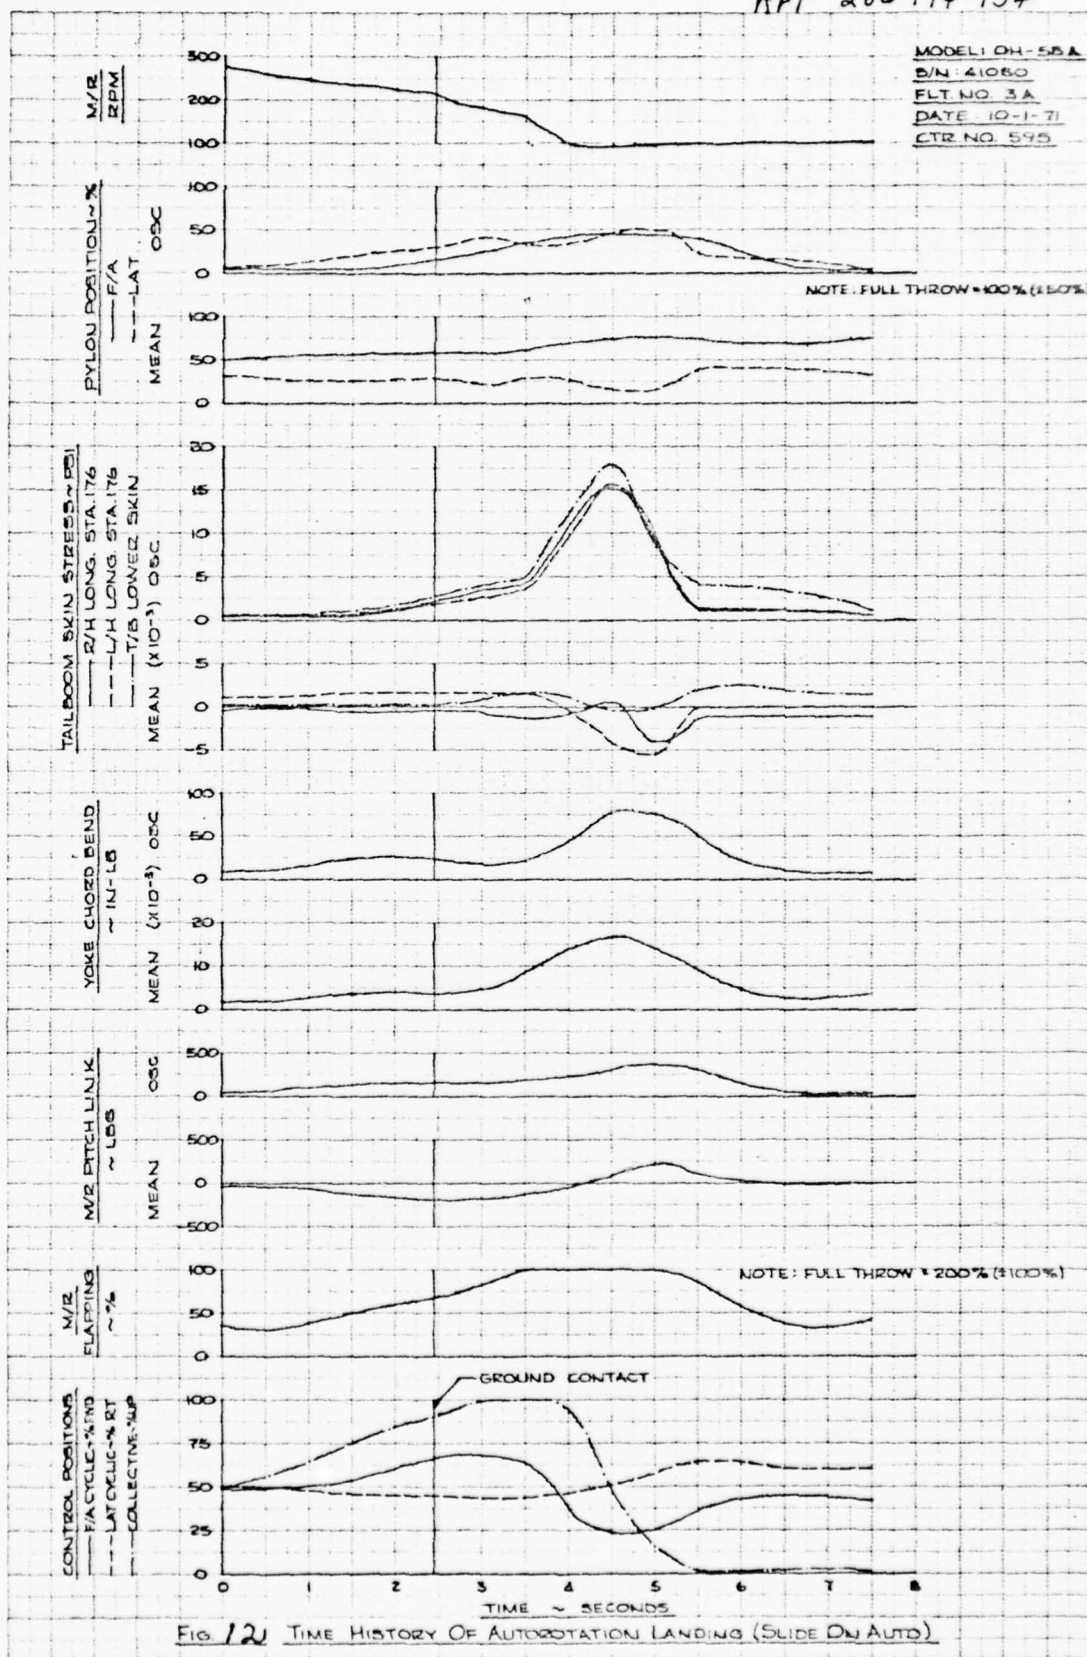
Comparison of Figure 11, a time history of a normal touchdown autorotation, and Figure 12, a time history of the touchdown autorotation when the tailboom failure occurred, tend to substantiate the influence of main rotor flapping with collective position, main rotor speed, and pylon behavior associated with the failure.

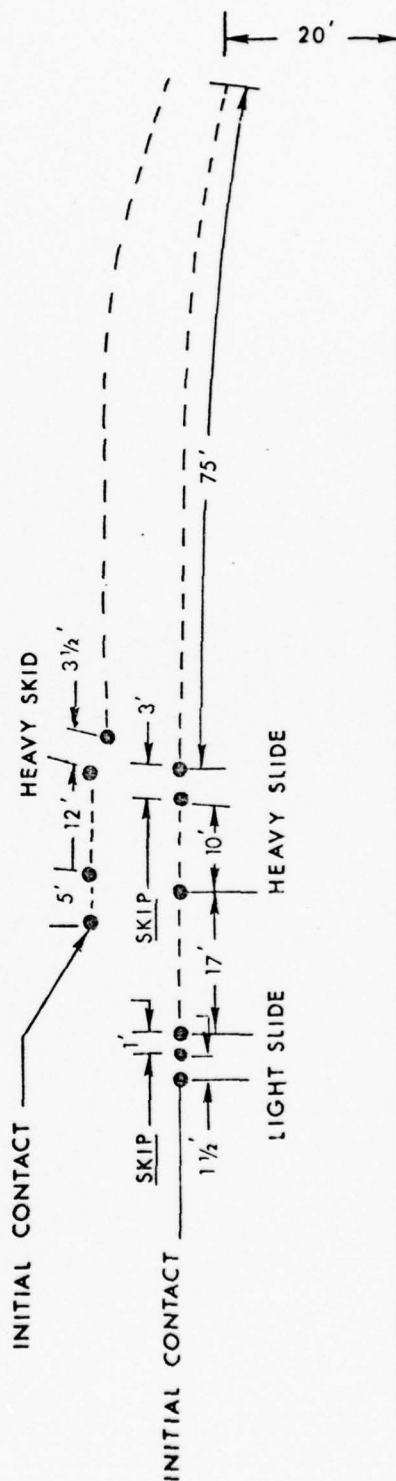
FIG 13 RUNWAY CONTACT

Figure 13 shows aircraft ground contact and subsequent ground roll, and Figures 14 through 20 are photographs depicting test vehicle damage that occurred during the evaluation. Figures 21 and 22 depict the extent of the pylon motion during the failure.

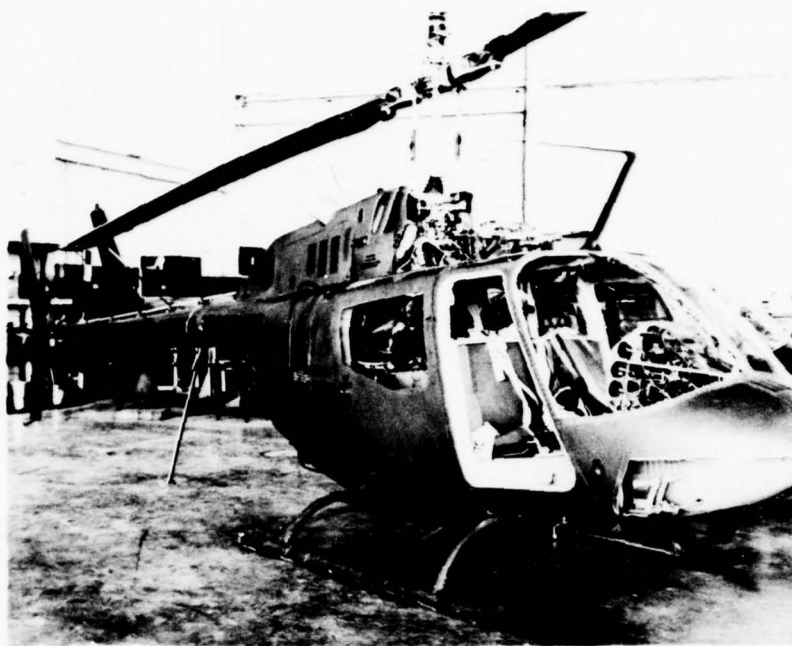
Fig. 14 Model OH-58A, S/N 41080, After Tailboom Failure, BHC Photo 284188

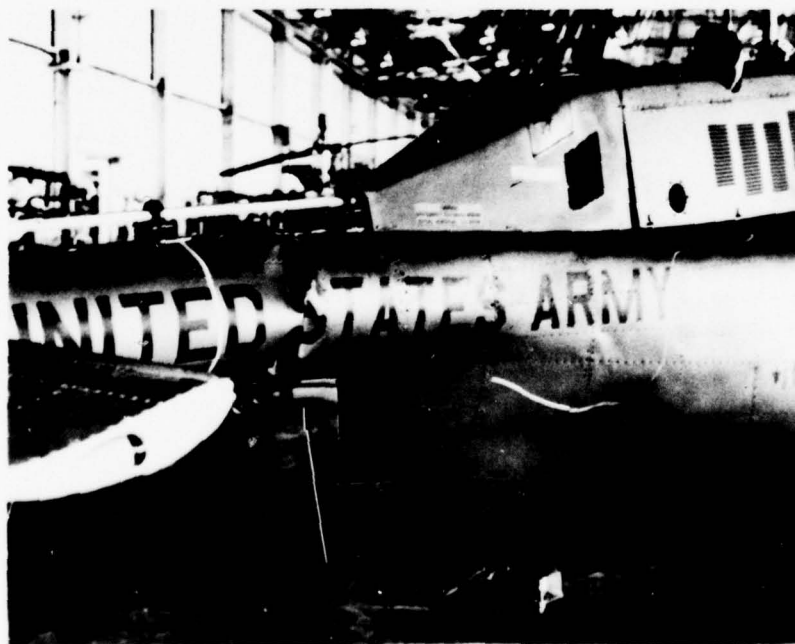
Fig. 15 Model OH-58A, S/N 41080, Right Aft View of Tailboom Failure at Fuselage Sta. 220, BHC Photo 284185

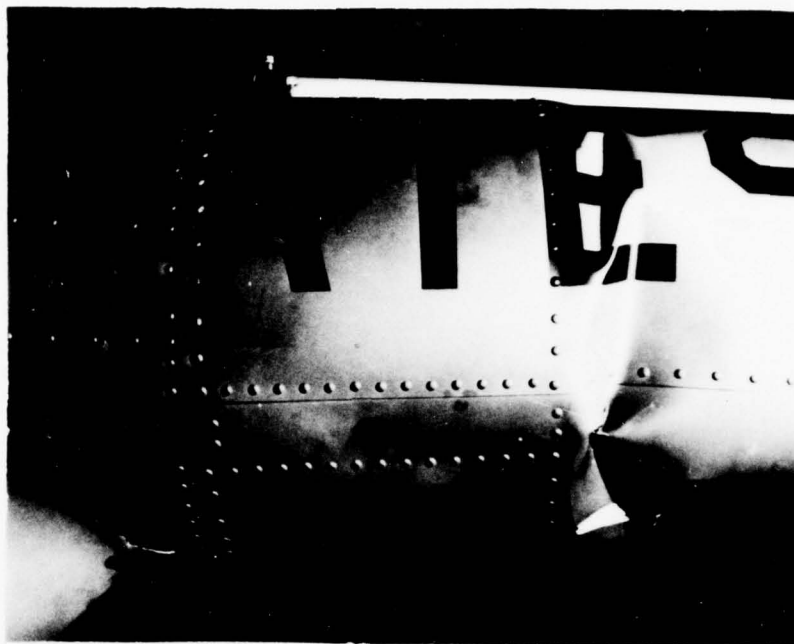
Fig. 16 Model OH-58A, S/N 41080, Tailboom  
Failure, Left Side, Fuselage Sta.  
220, BHC Photo 284177

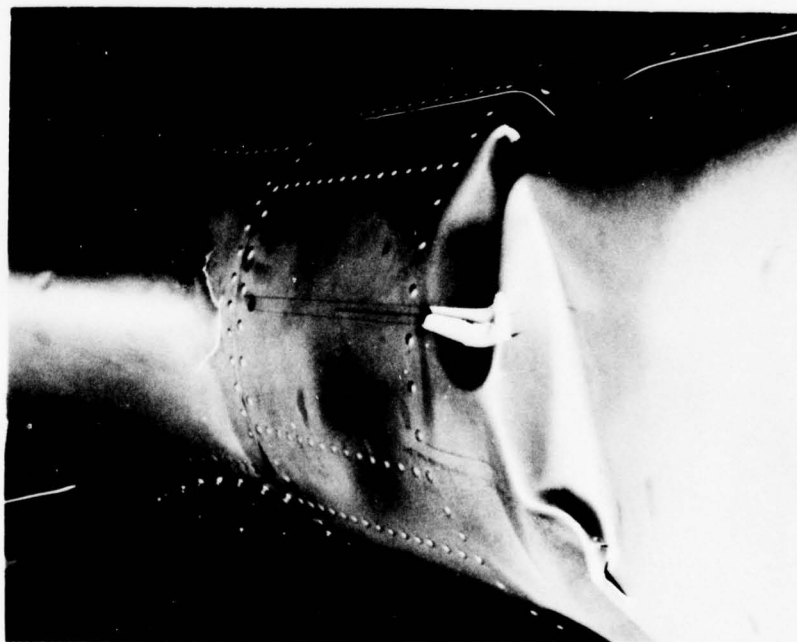
Fig. 17 Model OH-58A, S/N 41080, Tailboom  
Failure, Lower Surface, Fuselage  
Sta. 220, BHC Photo 284179

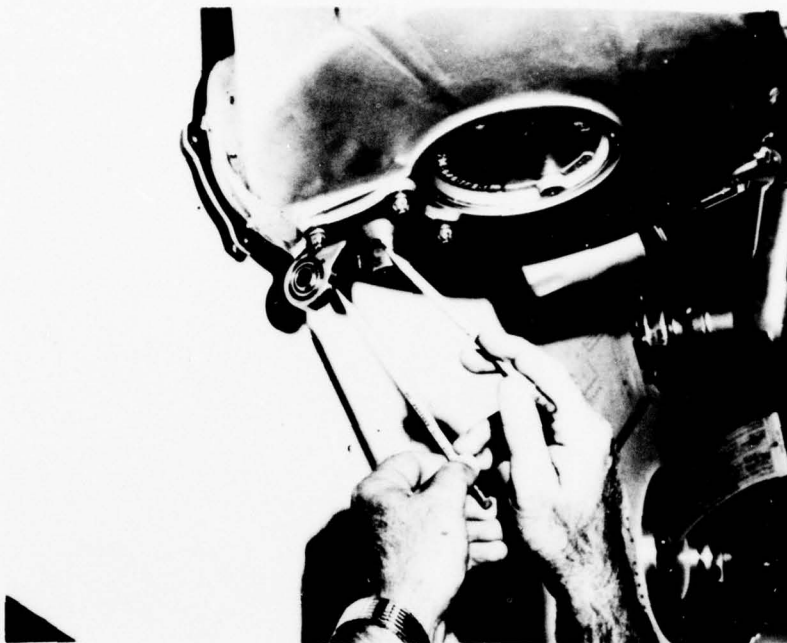
Fig. 18 Model OH-58A, Lower Transmission  
Case After Failure, BHC Photo 284118

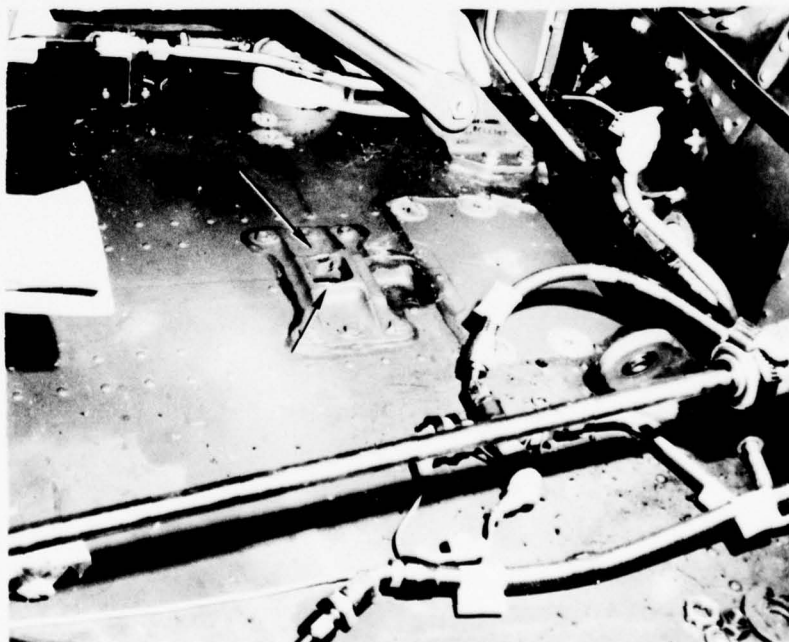
Fig. 19 Model OH-58A, Pylon Area After  
Tailboom Failure, BHC Photo  
284120

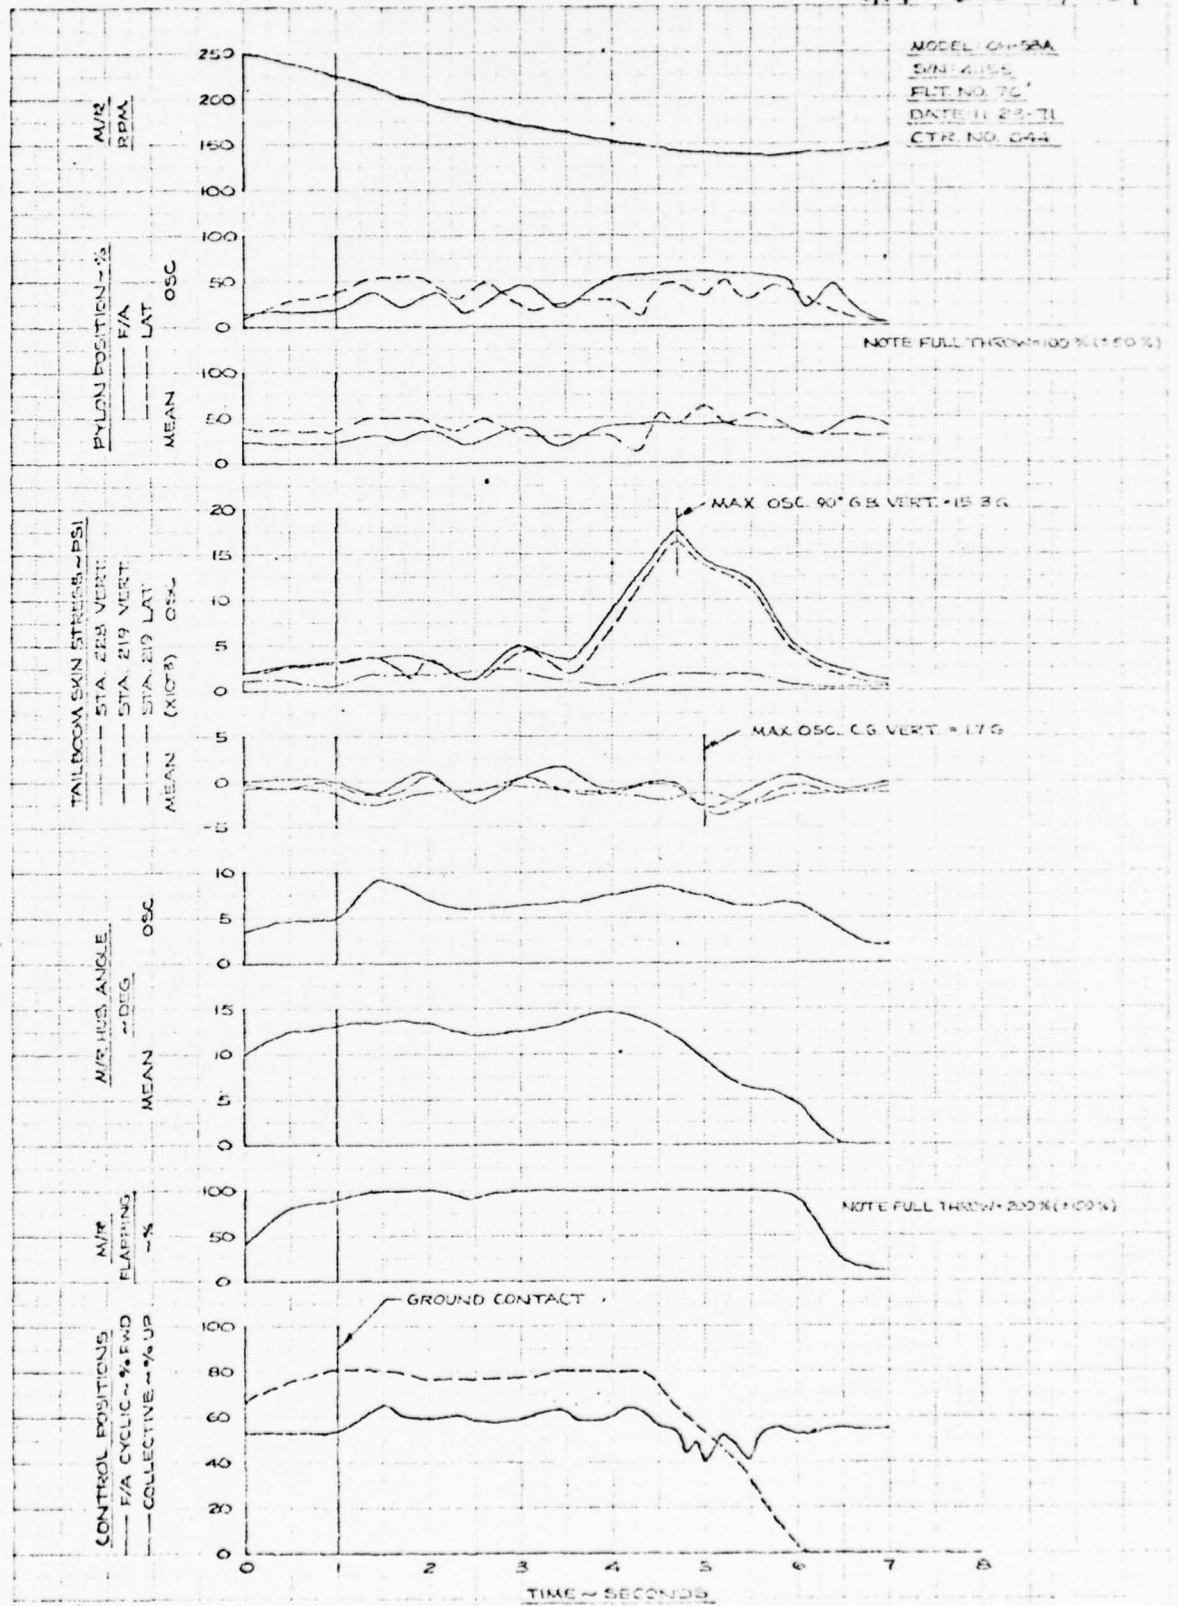
FIG 31 TIME HISTORY OF AUTOROTATION LANDING

A series of touchdown landings were made utilizing techniques that had produced tailboom failures in the past. Figure 31 presents a time history of an autorotation touchdown landing that produced a considerably high level of vertical tailboom excitation with a near damaging stress of 17,586 psi. The pilot reported the touchdown airspeed was probably in excess of 40 knots indicated airspeed (KIAS). Visible airframe damage was limited to minor pylon upper cowling contact and

cracked fiberglass fairing at the tailboom connection area. Aircraft damage was considered minor and tests continued. This documented autorotation landing incident is an additional substantiation of the computer study results.
